RICS HOME SURVEY LEVEL 2

- SURVEY ONLY

Example Report

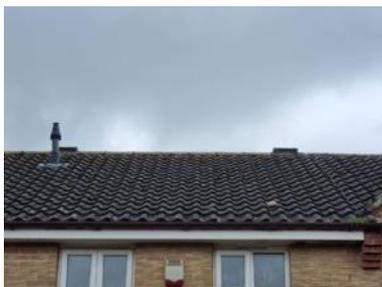
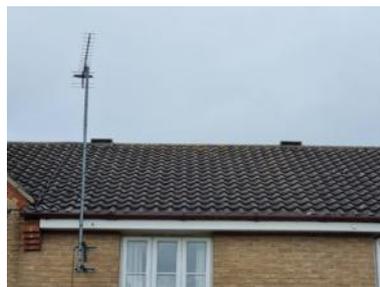
The roofline appears to be level and within normal tolerances with no signs of any significant deflection or undulation noted, indicating that the roof structure is adequate for the current roof covering. See Section E1 regarding the roof structure.

We are pleased to report the roof coverings appear to be complete with no signs of any slipped, missing or damaged covering noted.

There is moss growth present on the roof slopes. This level of moss growth is not unusual on properties of this age and type. You should monitor the roof slopes especially where they are north facing or shaded by trees. At present no action is required. However, in the future if the growth becomes excessive then the moss should be cleaned off. Moss growth impedes the run-off of rainwater and leads to gutter blockage and can cause water penetration which may lead to rot or other defects in surrounding timbers.

There is no apparent method of ventilation of the roof void. Please see section E1 of this report for further advice.

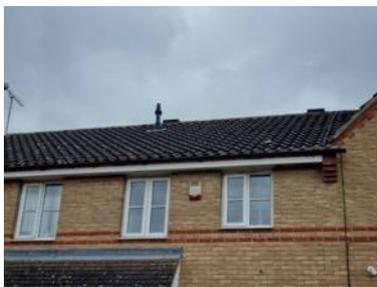
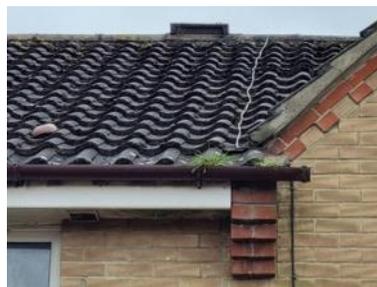
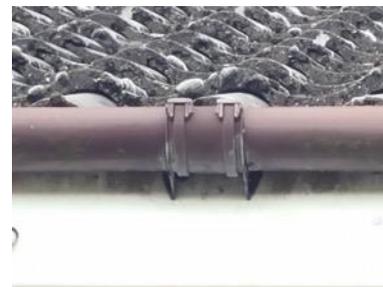
The rainwater goods are formed in uPVC and appear to be in a reasonable condition, however wants of repair have been identified.

We are pleased to report that rainwater goods appear to be adequately aligned with no signs of any significant twisting or distortion noted.

Some seepage was evident of the joints, most notably to the rear, suggesting that the joint seals have failed, and repairs will be required.

Please note it was not raining during the course of the inspection so we cannot confirm that rainwater goods are watertight at the joint sections. It is recommended that you inspect rainwater goods during a period of heavy rain in order to establish their effectiveness, with repairs addressed as found to be necessary.

You should ensure that the gutters are seasonally unblocked of moss and other debris.

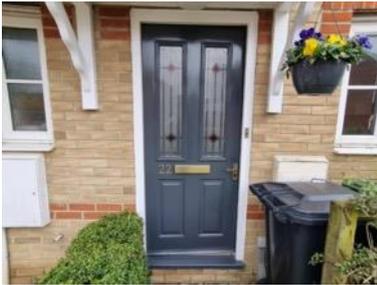
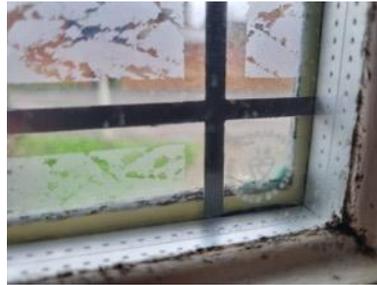
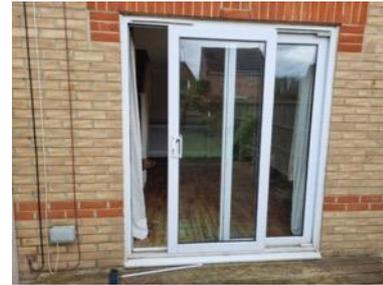
There was evidence of safety glazing having been provided. In the eventuality that replacement glazing will be required over a period of time, it should be ensured that safety glazing is installed.

We recommend you change all locks upon occupation to enhance security.

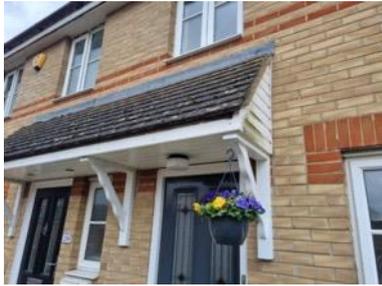
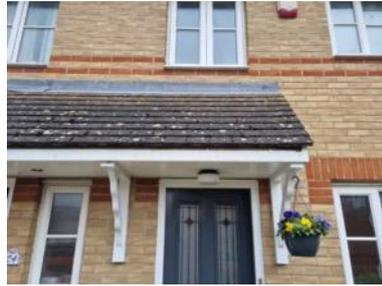
There is a small timber canopy porch to the front of the property, which is set beneath a pitched and tiled roof and is clad in uPVC. The canopy is in a reasonable condition.

The timber struts will require periodic redecoration to prevent the onset of timber decay. Decorations are currently serviceable however you must be aware of this ongoing maintenance requirement.

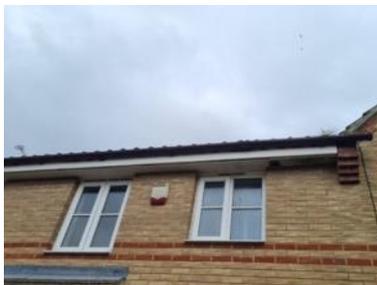
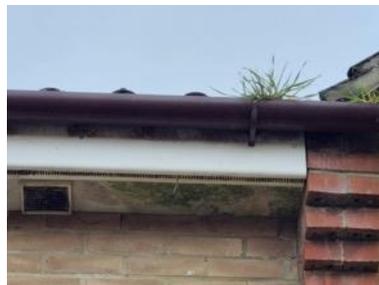
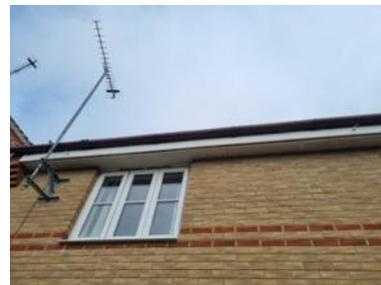
Staining of the soffit was noted to the front righthand corner of the property, and this is believed to have been caused by overspill from the above blocked gutter. The advice in section D3 of this report must be followed.

We found no evidence of penetrating dampness internally, however the risk of concealed defect does exist beneath the internal wall of the bathroom.

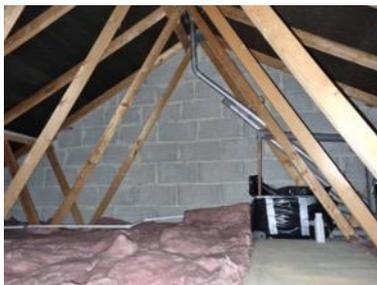
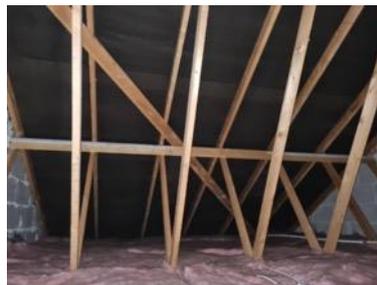
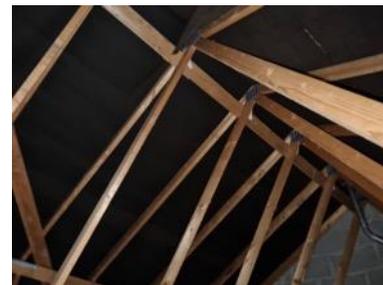
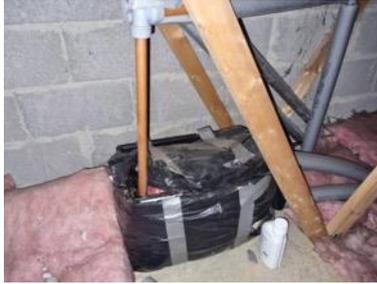
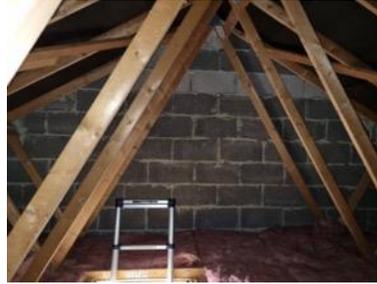
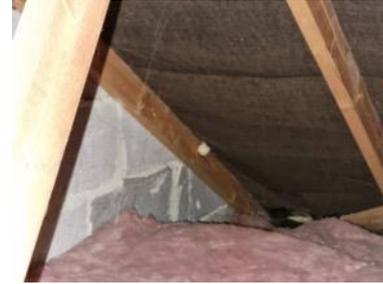
The cold-water storage tanks are of plastic construction and are adequately covered, supported and insulated, with overflow pipes extending to the exterior of the property.

There were wasps' nests visible in the attic space. These appeared to be dormant, but you should be mindful of further nests that may be present in hot summer months.

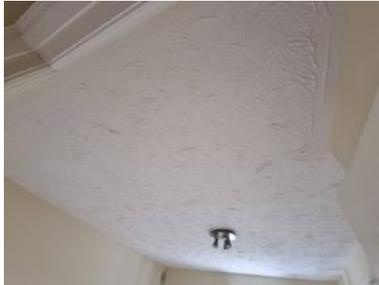
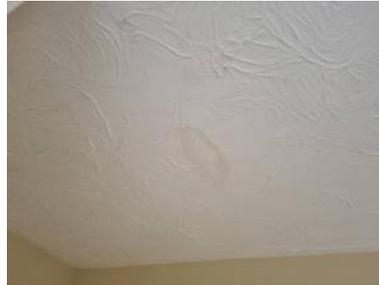
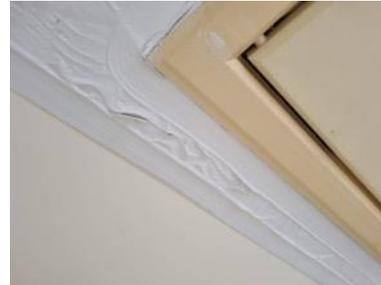
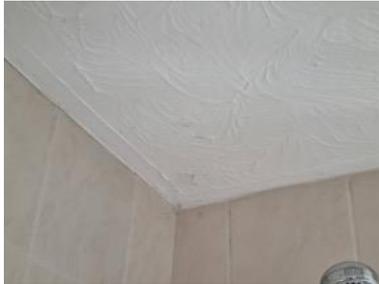
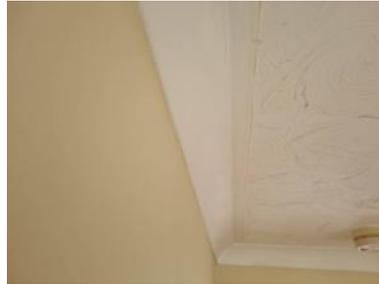
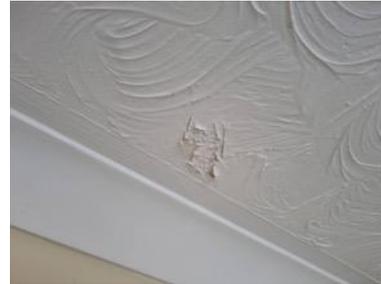
Peeling decorations were also noted within the kitchen, this area was found to be dry and we believe it has been caused either by heat transference from the above hot water cylinder, or a historic leak.

Following on from advice through an asbestos specialist, the loose and peeling plasterwork and decorations should be stripped, prior to making good and you should make allowances for this.

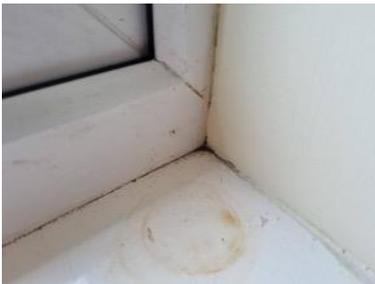
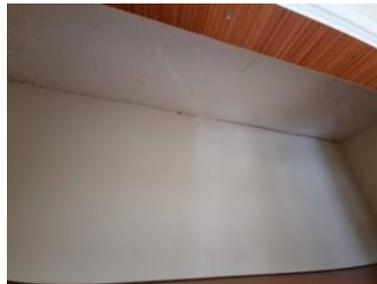
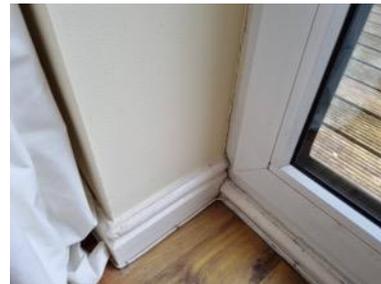
There are mould spores to the walls within the window and door reveals which is believed to have been caused by condensation, which is common in these locations in a property of this age. The mould will require cleaning with an anti-fungal product prior to redecorations.

Condensation can be reduced on occupation by maintaining a consistent balance of heating and ventilation, together with improvements to insulation where required.

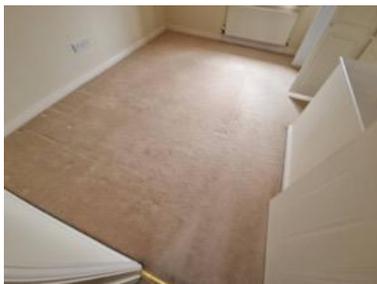
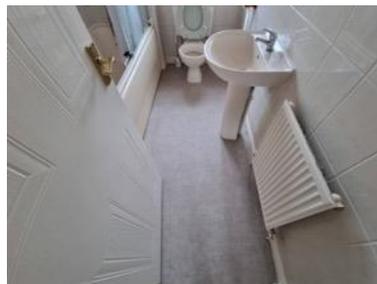
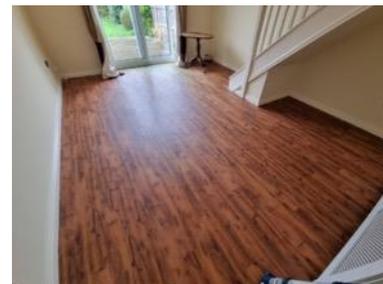
Vinyl coverings to the bathroom can trap moisture beneath which could cause damage to suspended timber floors over time. No repair is urgently required but we recommend you replace this floor covering with a more suitable floor covering in the long term.

The floor coverings throughout the property are old, worn, and marked and you should consider replacing these to your own taste as part of the general improvement to the property.

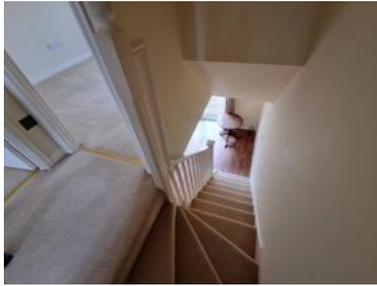
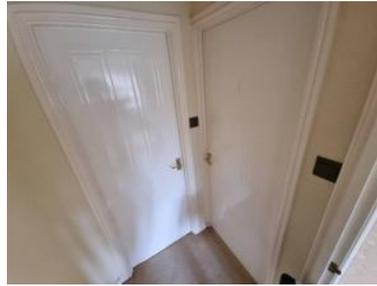
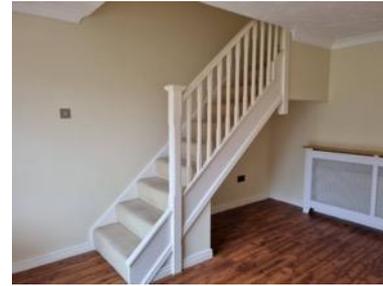
Banisters and balustrading appear to be complete with no signs of any defect noted. The gaps between spindles are 100mm or less which will comply with current Building Regulation standards.

The handrail and spindles are loose with undue levels of movement during usage, and these should be fixed as the current arrangements are hazardous if placed under undue pressure. You should make allowances for this.

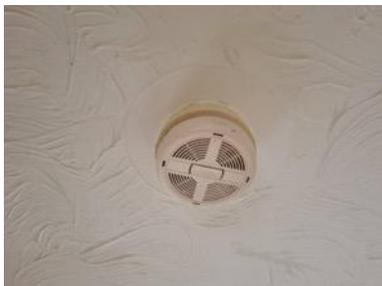
Where there is a gas-fired boiler and a gas hob, carbon monoxide alarms should be installed adjacent to the appliance in line with the alarm manufacturer's guidelines as a matter of urgency.

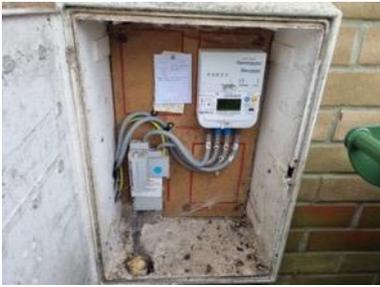
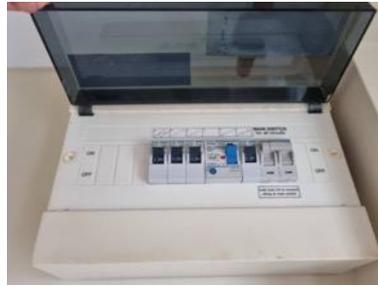
We have concerns regarding the age of the installation which we believe will not meet current safety standards. Due to our concerns, together with no signs of a recent test of the electrical installation, we recommend an electrical inspection is completed prior to legal commitment to purchase with all recommendations fully costed and implemented.

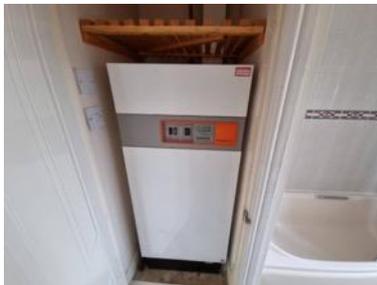
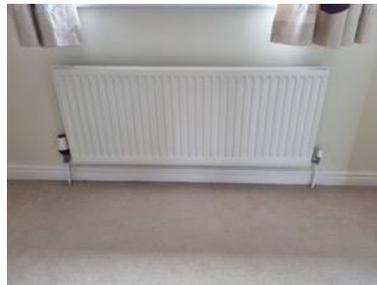
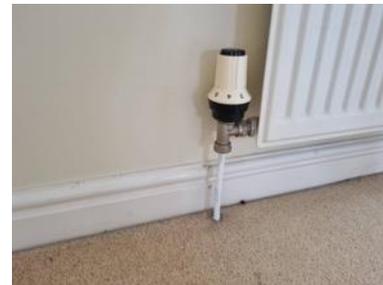
Thermostatic radiator valves (TRVs) have been provided to radiators. These will allow for individual control over each unit which will improve the thermal efficiency of the dwelling.

Given the age of the radiators they are likely to be inefficient compared to modern equivalents and you may wish to consider upgrading as part of the overall improvement of the property.
