**RICS HOME SURVEY
LEVEL 3**

Example Report

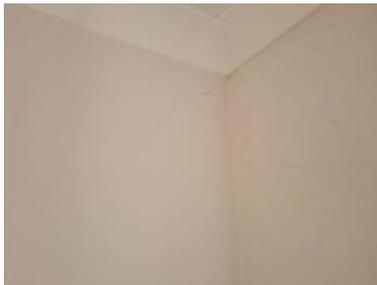
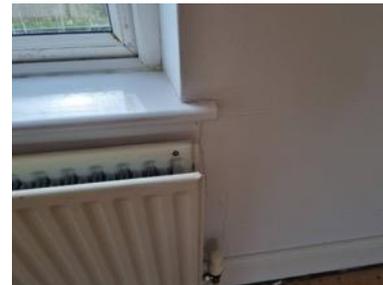
Water damaged finishes

Additionally, saturated plasterwork and decaying windowsill timbers were observed within the bathroom. This has been caused by a lack of protection to these areas from the use of the adjacent shower, causing significant water damage.

The plasterwork will need to be hacked off in this location, and the window board removed, with a drying out period undertaken to the below masonry. This will then require making good through replastering, renewal of the windowsill, and suitable waterproofing finishes, such as wall tiles, plastic cladding, or specialist 'Mermaid boards'. You should seek further advice and quotations in this regard prior to purchase, with the repairs undertaken as soon as it is possible to do so.

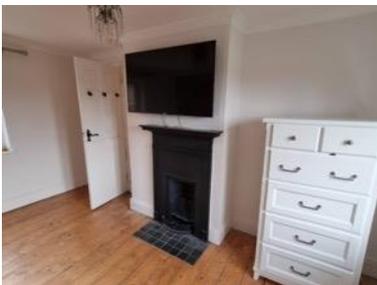
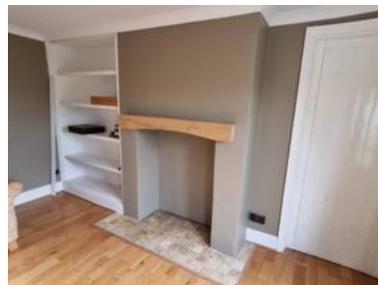
As previously advised, high moisture readings have been detected within the internal chimney masonry and the recommendations made in section D1 of this report should be followed to alleviate this. These works include capping and ventilating the open pots and undertaking repointing works across the stack.

The chimney breast appears sound. However, it was not possible within the limits of this report to inspect the flues in detail or to assess the internal condition of flues or flue liners and we can give no assurances as to the practicalities of reinstating the fireplaces. Further contractor's advice will need to be sought in this regard should you wish to utilise the fireplaces.

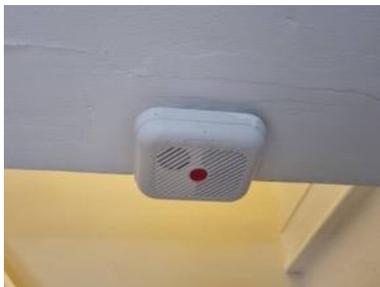
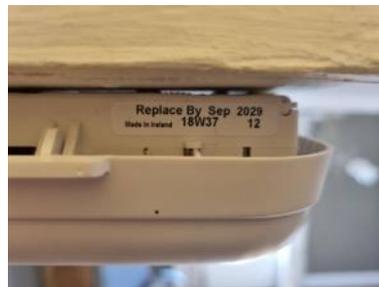
The smoke detector installed to the ground floor will expire in September 2029.
