RICS HOME SURVEY LEVEL 2

- SURVEY & VALUATION

Example Report

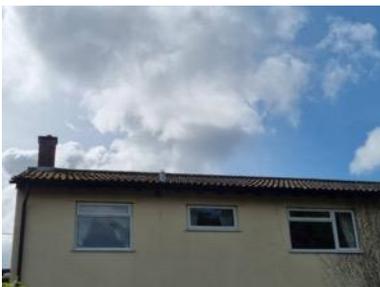
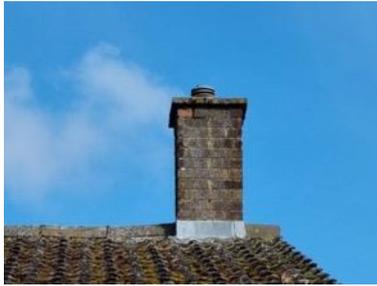
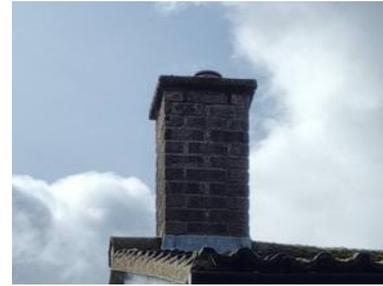
D1 Chimney Stacks

Whilst the level of deterioration is relatively minimal at this time with no requirement for repair, you should be aware that spalling is progressive, unsightly and if allowed to continue may ultimately result in structural failure of the stack. The affected masonry should be periodically monitored and the need to cut-out and replace individual bricks in the future cannot be ruled out.

Scaffolding or other means of safe access will be required to carry out future repairs which will increase the cost significantly and you should budget accordingly.

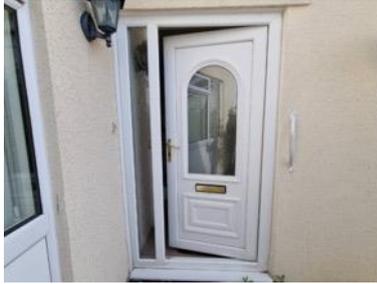
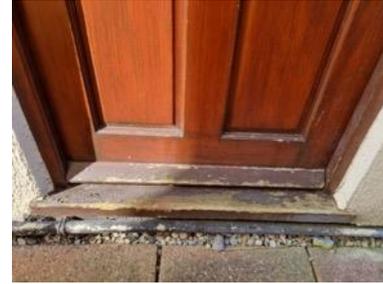
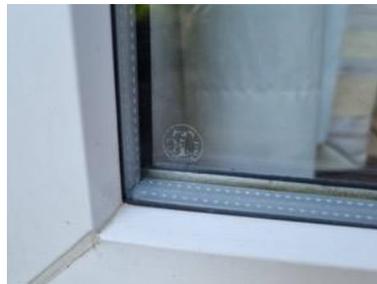
External timber decorations will need regular redecoration, typically on a three-to-five-year cycle dependent upon the quality of paint or stain coating. The decorations are weathered and deteriorated and new decoration in reasonable course will be required, however we have already recommended that the entire unit is replaced.

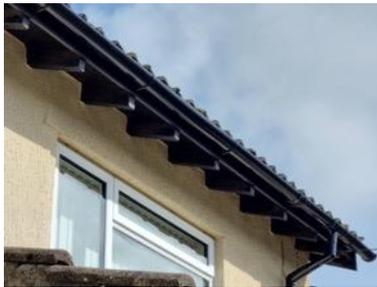
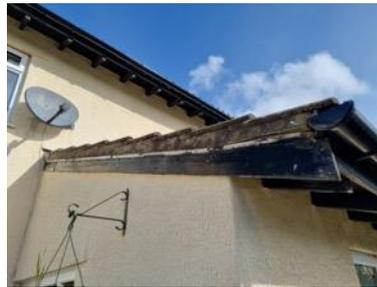
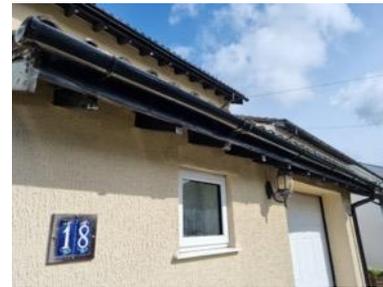
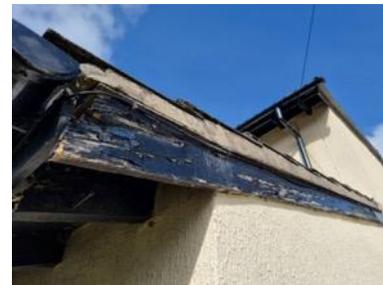
A general overhaul of the timber roof edge materials is required, to include treatment by a timber specialist, localised cutting out and repair, and sanding and redecoration. Alternatively, may wish to consider replacing the joinery with uPVC variants as a more economical solution, which will require less maintenance moving forward.

Much of this work will be at height and you should therefore seek further advice and quotations for the repairs prior to commitment to purchase, in order to budget accordingly.

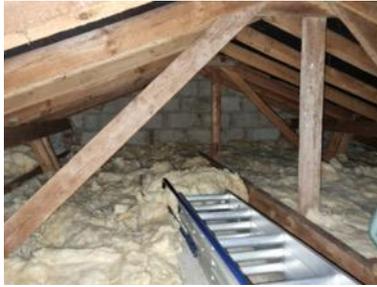
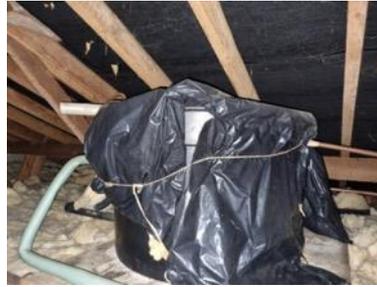
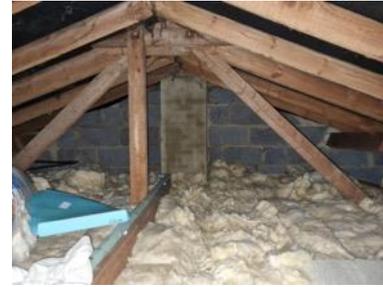
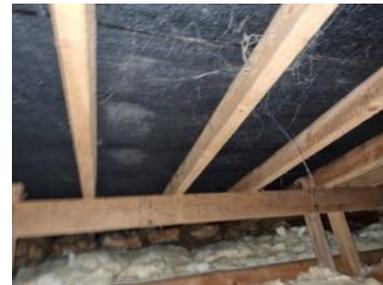
In places, electrical wiring is present beneath the loft insulation. This can cause overheating and in extreme cases lead to fires. All covered cables must be re-positioned on top of the insulation, and this should be assessed as part of a specialist Electrical test. Please see also section F1 of this report.

The cold-water storage tanks are of plastic construction and are adequately covered, supported and insulated, with overflow pipes extending to the exterior of the property. Please refer to section F3 of this report for further comment.

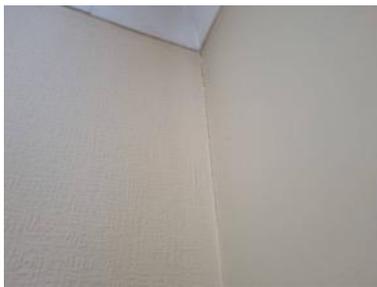
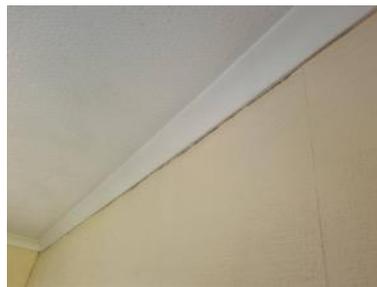
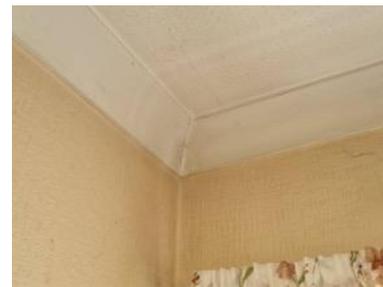
There are mould spores to the walls within the some of the external corners, window, and door reveals which is believed to have been caused by this condensation. The mould will require cleaning with an anti-fungal product prior to redecorations.

Condensation can be reduced on taking occupation by maintaining consistent ventilation and heating, and through upgrades to insulation where possible. Please see also sections E6 and E8 of this report.

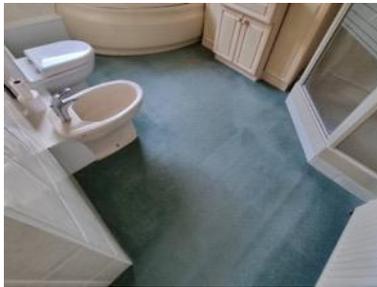
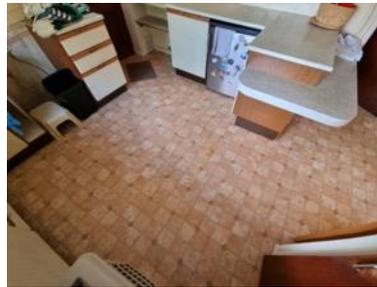
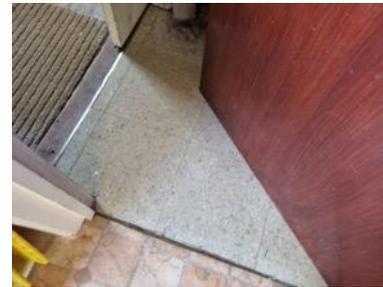
E4 Floors

The floor coverings throughout the property are old, worn, and stained. You should consider replacing these to your own taste as part of the general improvement to the property.

There are floor tiles present within the inner hall to the garage and given the age of the property these may contain small amounts of asbestos based materials. No damage was noted to these tiles however they should not be disturbed or damaged and care should be taken during future maintenance.

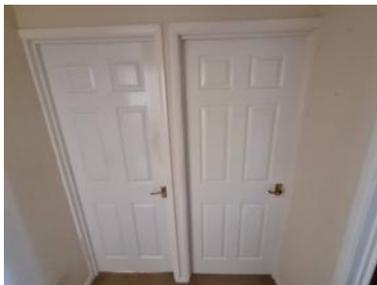
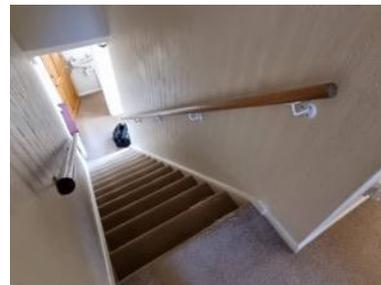
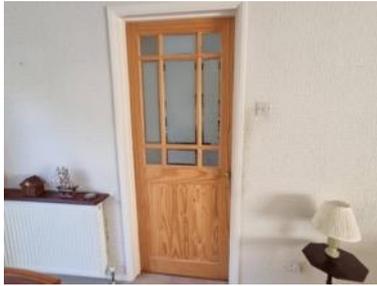
The property has a timber staircase which is carpeted on the upper surface and enclosed beneath. Treads and risers appear to be firm and level and within normal tolerances, with no signs of any significant spring or undulation noted.

Current Building Regulation standards recommend a height of between 900-1000mm to handrails, banisters and balustrading within Part K – Protection from Falling, Collision and Impact of the current Building Regulations. As the height of the handrails does not fall within 900-1000mm, the banisters should ideally be modified on taking occupation as the current arrangements are hazardous.

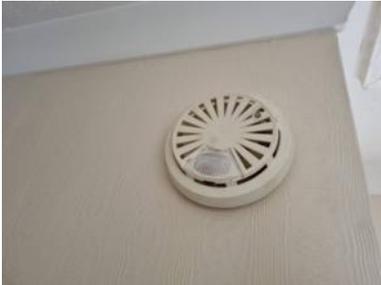
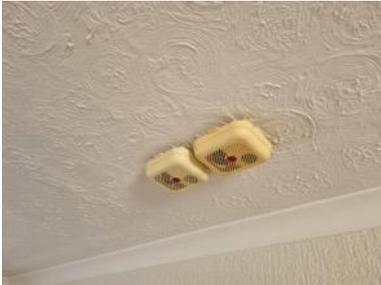
Carbon monoxide alarms should be provided in all rooms which house a fuel-burning appliance.

Where there is a gas-fired boiler within the kitchen, a carbon monoxide alarm should be installed adjacent to the appliance in line with the alarm manufacturer's guidelines as a matter of urgency.

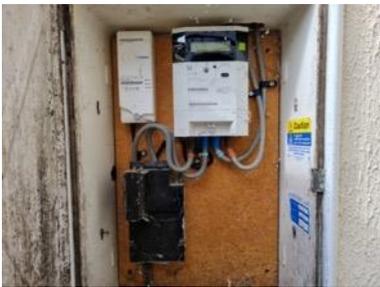
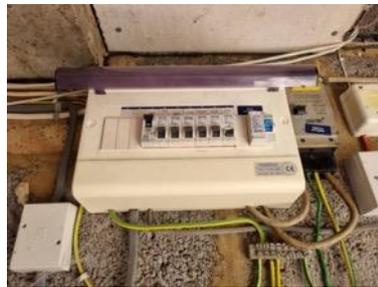
We have concerns regarding the age of the installation which we believe will not meet current safety standards. Due to our concerns, together with no signs of a recent test of the electrical installation, we recommend an electrical inspection is completed prior to legal commitment to purchase with all recommendations fully costed and implemented.

The electrical installation is provided with an RCD which is designed to protect the users from electric shock. These installations are extremely sensitive and consequently occasional tripping of switches will occur, effectively shutting down the affected circuit(s). It can often result when a light bulb fails, or it may be the result of a defective appliance. When this happens, the 'trip-switch' must be reset. If this occurs with any frequency, an electrician should be instructed to investigate.

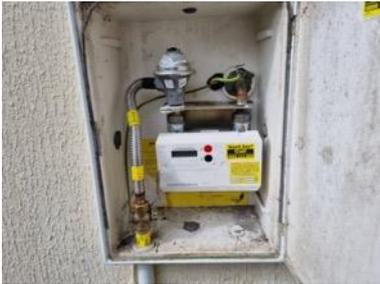
For precautionary purposes it is recommended that the gas installation be inspected by a Gas Safe registered engineer prior to legal commitment to purchase in the absence of any documentary evidence dated in the last 12 months. All recommendations for improvement to ensure compliance with current Gas Regulation standards should be implemented.

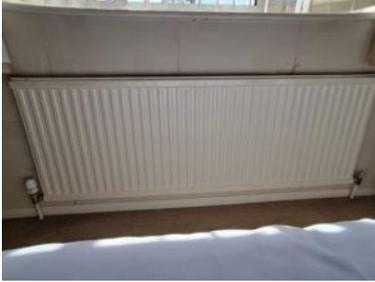
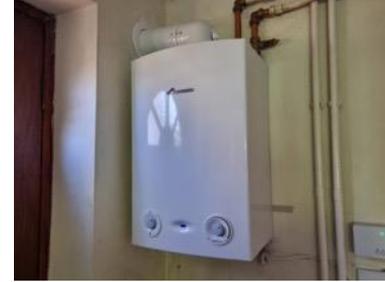
Given the age of the radiators however, they are likely to be inefficient compared to modern equivalents and you may wish to consider upgrading as part of the overall improvement of the property.

A significant amount of the central heating pipework is buried within the construction and whilst there were no signs of leakage, this can occur undetected beneath floor finishes, particularly if pipework is not adequately protected.

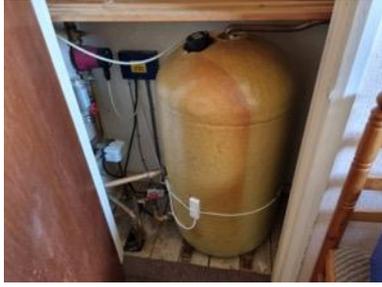
The cylinder appears relatively old, with some slight surface corrosion observed. Whilst no leakages were recorded, consideration should be given to replacing the cylinder with a modern equivalent. You may wish to have the installation inspected by a heating engineer prior to purchase, with quotations obtained to upgrade the installation, in order to budget accordingly.

You should be aware that hot water systems require regular maintenance, and it is recommended that they are serviced annually alongside the central heating boiler installation. You should request a copy of any recent service history through your legal adviser. In the absence of such documentation dated within the last 12 months, you should arrange for a precautionary inspection through a reputable plumber or heating engineer.

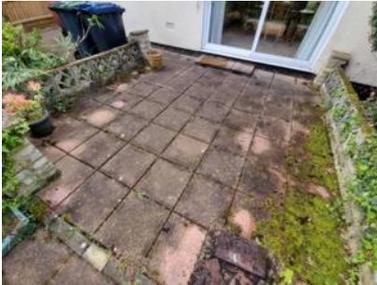
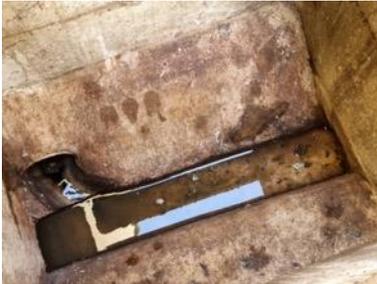
Where there is extensive hardstanding ground provided to the front, rear, and side of the plot and we do not believe that surface water drainage is adequately provided, particularly where the ground levels are slightly uneven. There is a potential for slow surface water run-off, sitting water, and potentially flash flooding during heavy rainfall.

Further advice from a reputable landscaper or drainage specialist should be sought in this regard with all recommendations for improvement fully costed prior to purchase.

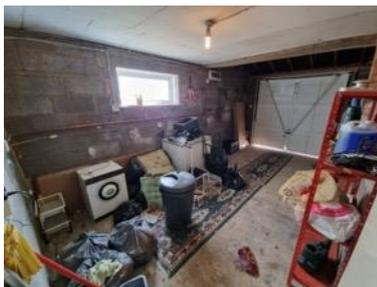
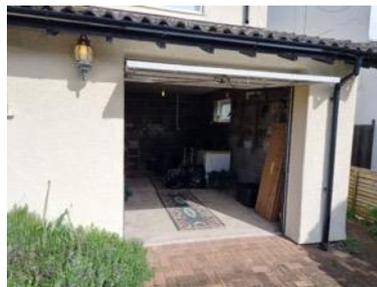
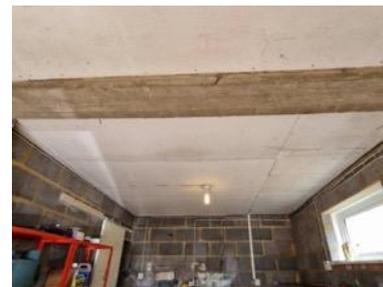
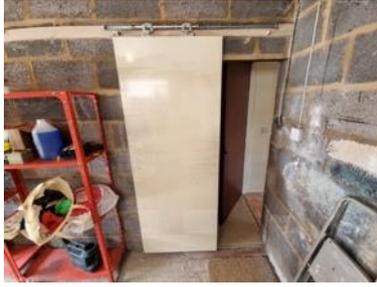
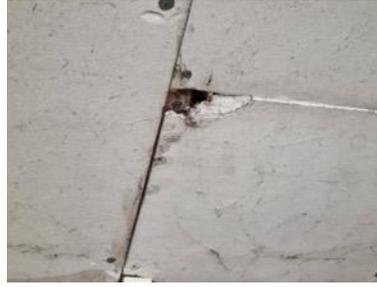
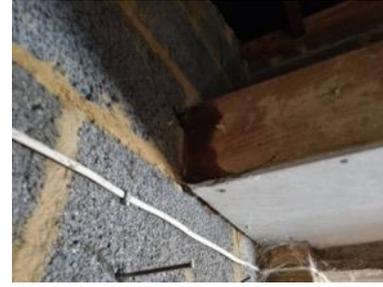
The electrical services to the garage should be tested by a qualified electrician alongside the electrics to the property. Please see also section F1 of this report.
