RICS HOME SURVEY LEVEL 2

- SURVEY ONLY

Example Report

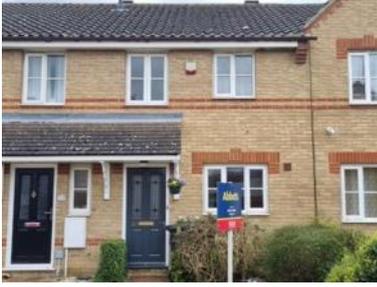
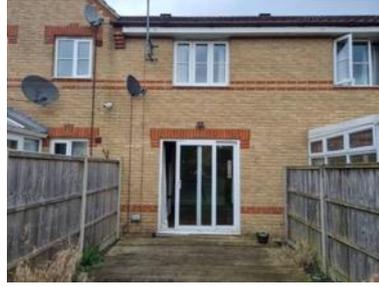
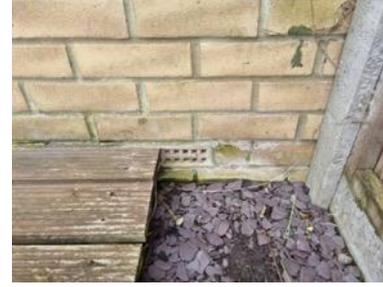
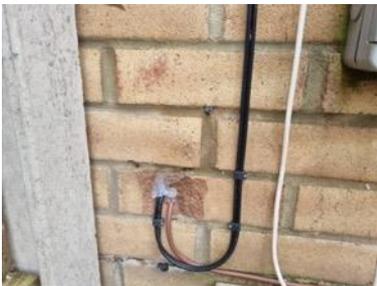
We inspected the property during the day. At the time of our inspection no significant sound from adjoining properties was noted. It is possible, dependent upon the lifestyle of neighbours that sound transmissions will be encountered during your occupation of the property and which in extreme cases could affect your quiet enjoyment.

Condition Rating: 2

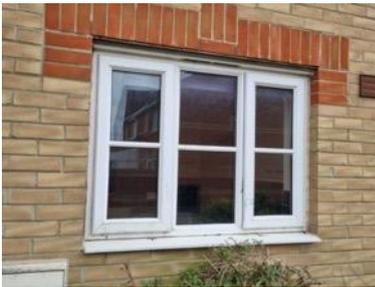
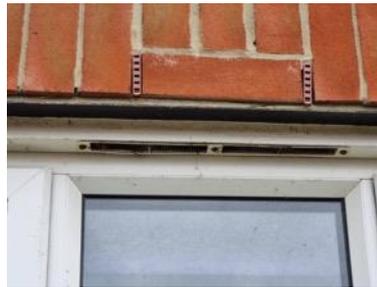
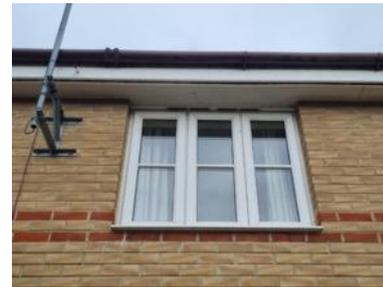
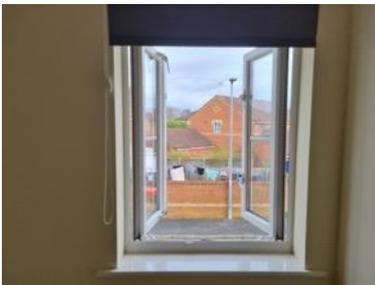
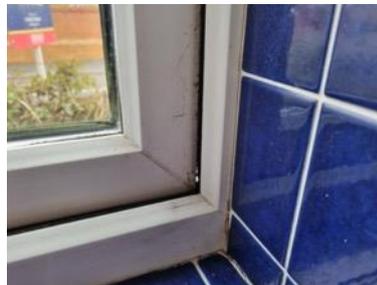
Where trickle ventilation has been provided to windows, this should allow a degree of natural ventilation when windows are closed.

You should ensure that you are provided with a full set of window keys on occupation.

Condition Rating: 2

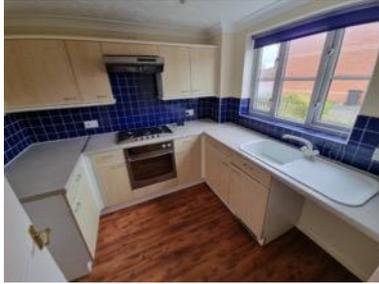
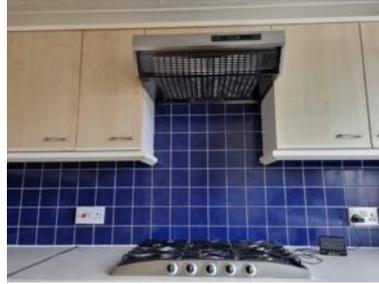
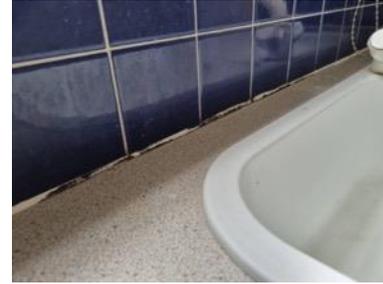
There is a gas hob fitted and you should confirm with your legal adviser whether this has any Gas Safety Certification. See Section F2 of this report.

Most of the distribution and waste pipework is concealed behind the units and leaking pipework or other defects may not be readily apparent.

Condition Rating: 2

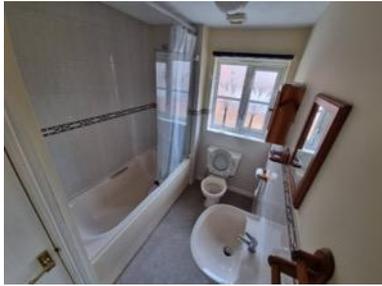
The water pressure was checked to several draw-off points and found to be adequate. Water pressure can vary seasonally and during times of high demand, both within the property and in the locality. It is recommended that should you wish to install water pressure sensitive items, such as a power shower, that further enquiries are made initially.

Most of the distribution and waste pipework is concealed beneath or behind sanitary ware items and whilst there were no obvious signs of leaks, the risk of hidden defects exists.

Condition Rating: 2

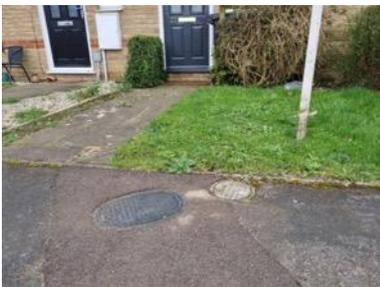
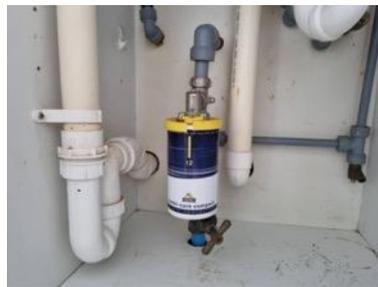
The external stop tap is located in the footpath to the front of the property. You should confirm whether a water meter is provided.

It is possible that the incoming mains water supply line to the property is common to the this and neighbouring properties, and therefore could be subject to demand related fluctuations in pressure. Further investigations through either the Water Company or a reputable plumbing contractor would need to be made to confirm this.

Condition Rating: 2

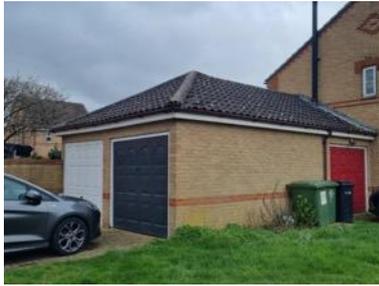
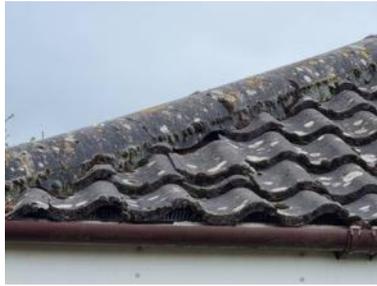
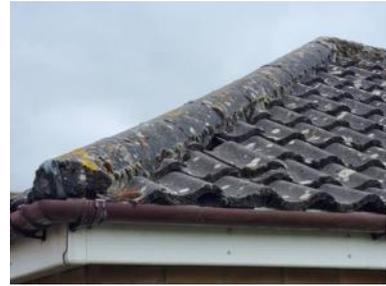
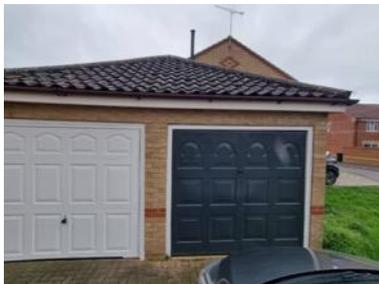
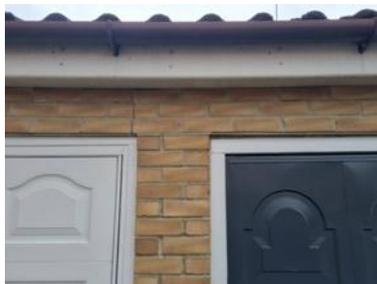
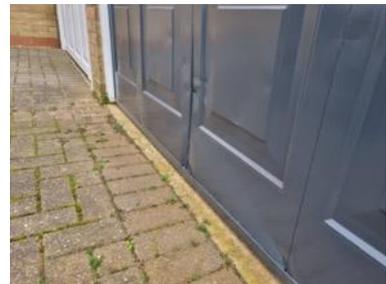
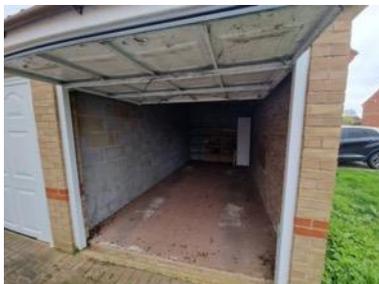
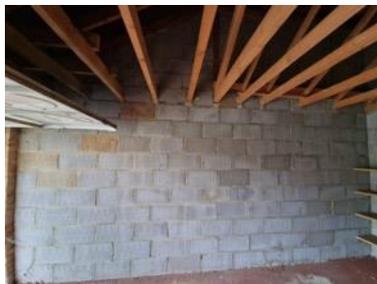
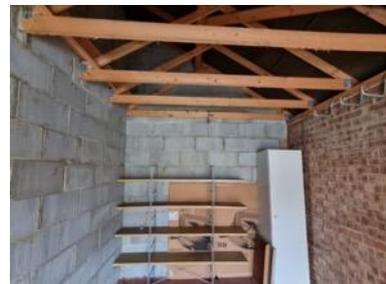
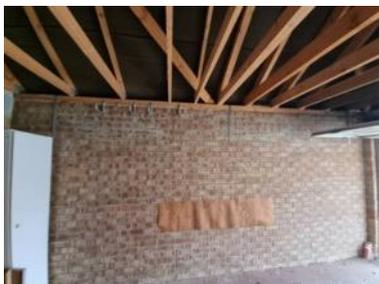
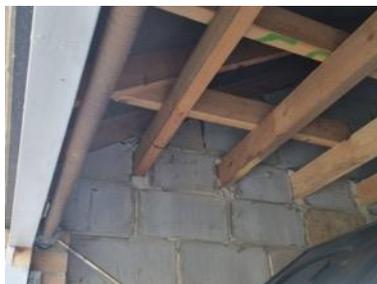
The party walls between the subject and neighbouring properties are complete and fully sealed, provided adequate fire and security separation.

You should confirm with your legal adviser rights of ownership, access and responsibility for maintenance for the access driveway to the garage block.

Condition Rating: **2**

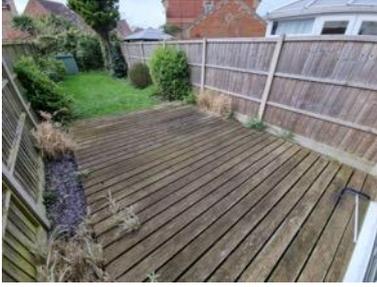
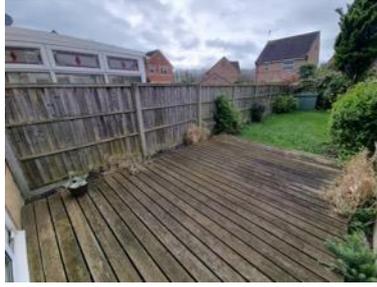
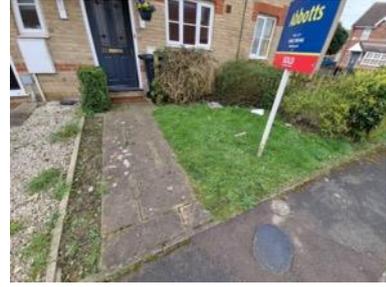
It is recommended that a certified copy of the Deed Plans be obtained, and boundaries checked on site, with any discrepancies investigated further, to assist in reducing the possibility of boundary disputes with adjoining owners.

Whilst there was no evidence of any adverse easements, servitudes or wayleaves affecting the property your legal advisers should be asked to verify. See Section I2.
