**RICS HOME SURVEY
LEVEL 3**

Example Report

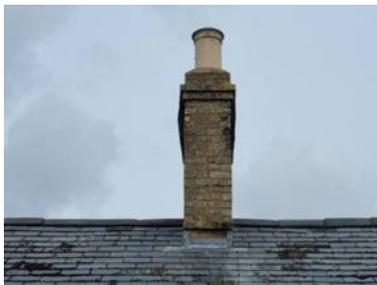
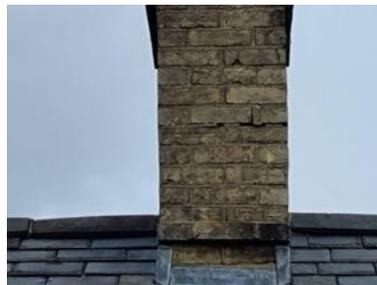
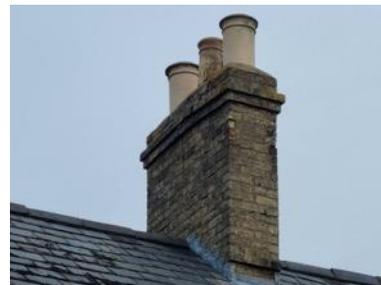
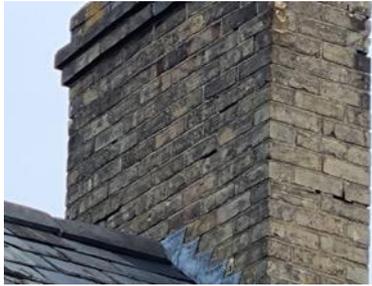
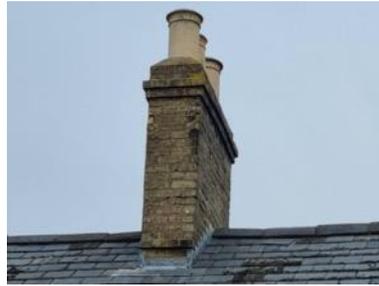
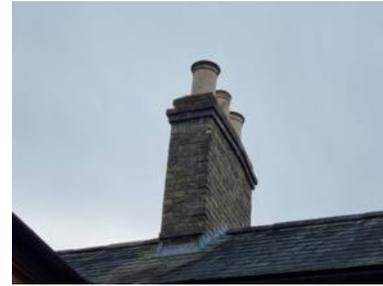
Condition Rating: **3**

Repairs are now required. You should seek quotations to repoint the stack and cap the open pots through a reputable roofing contractor prior to purchase. Scaffolding or other means of safe access will be required to carry out repairs which will increase the cost significantly and you should budget accordingly.

Lichen and moss should be cleared from the top courses periodically to prevent early deterioration of brickwork pointing. The level of moss growth is not significant at this time. Please be aware, it may be necessary to repoint brickwork once moss has been cleared during future maintenance.

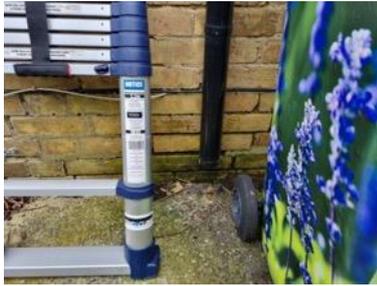
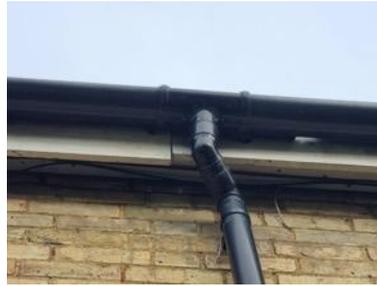
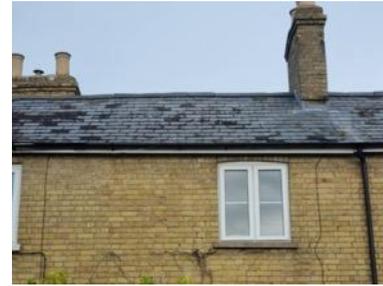
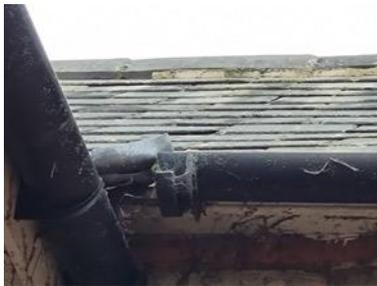
Please note it was not raining during the course of the inspection so we cannot confirm that rainwater goods are watertight at the joint sections. It is recommended that you inspect rainwater goods during a period of heavy rain in order to establish their effectiveness, with additional repairs addressed as found to be necessary.

You should ensure that the gutters are seasonally unblocked of moss and other debris.

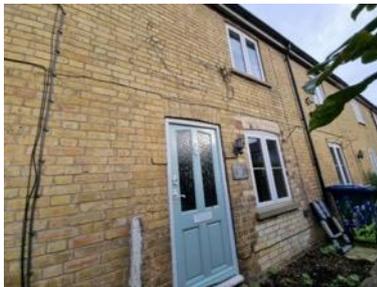
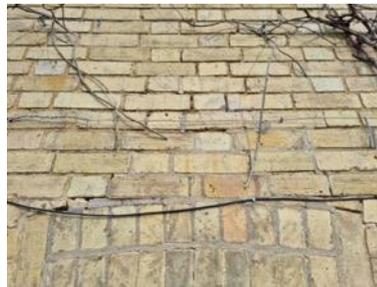
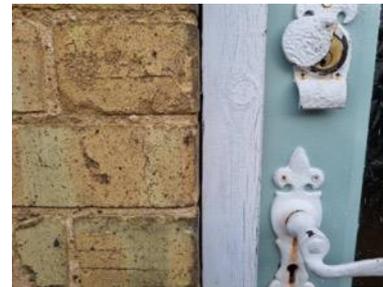
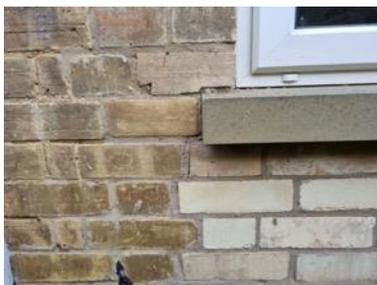
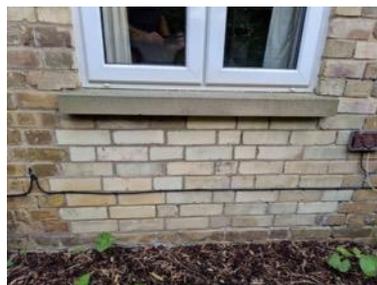
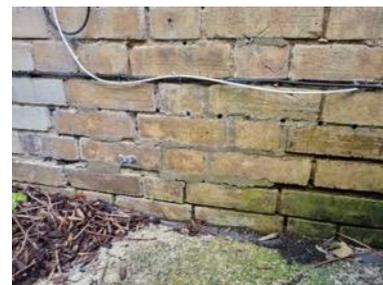
We inspected the property during the day. At the time of our inspection no significant sound from adjoining properties was noted. Regarding the age of the property it is unlikely any effective sound insulation was provided between adjoining properties at the time of construction. Therefore, it is possible, dependent upon the lifestyle of neighbours that sound transmissions will be encountered during your occupation of the property and which in extreme cases could affect your quiet enjoyment.

Subsoils within the area may include shrinkable clay and these are subject to seasonal changes in ground conditions. You should maintain trees and shrubs close to the property in order that ground conditions remain as stable as possible.

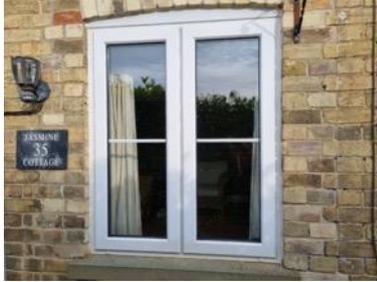
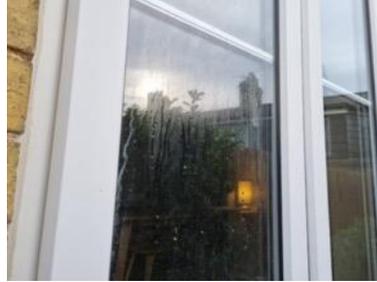
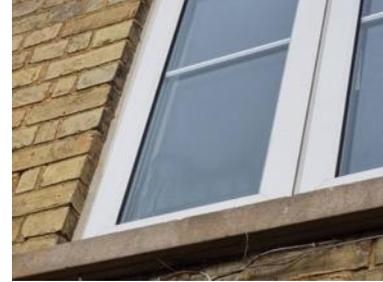
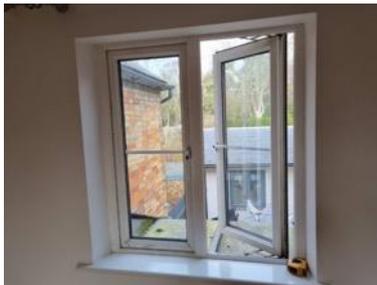
Condition Rating: 3

In view of the overall condition of the window units, we recommend that these are replaced in the short term, and you should seek quotations for these works prior to commitment to purchase, in order to budget accordingly.

Please be aware, there may be restrictions on the types of units that can be installed, given that the property is in a conservation area, Local Authority advice is required in this regard.
You should ensure that you are provided with a full set of window keys on occupation.

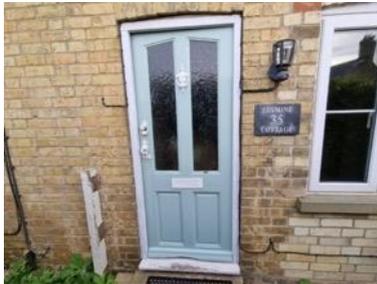
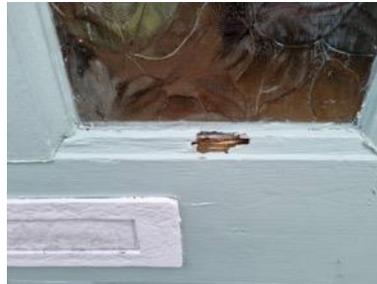
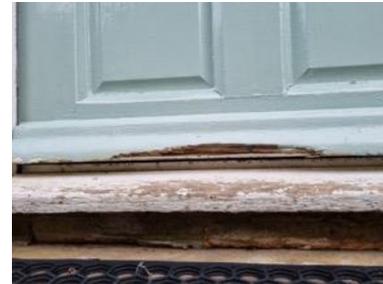
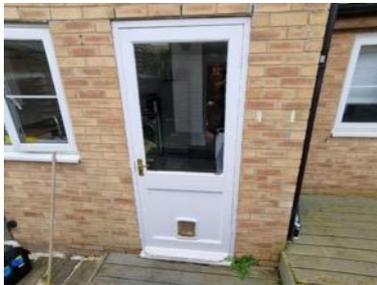
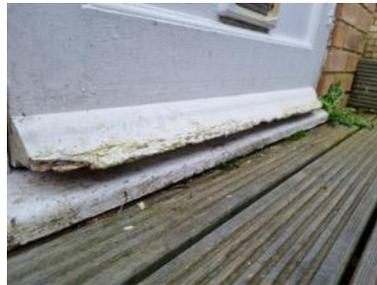
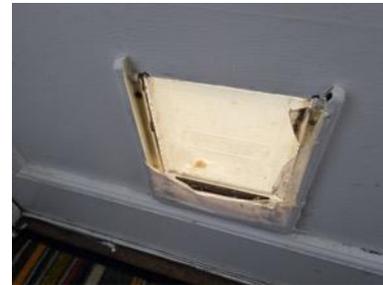
The doors are of single-glazed timber construction and appear to be in a generally poor condition.

The external timber decorations will require periodic renewal in order to offset timber decay. The decorations are suffering from deterioration and areas of softwood and decay were noted across both units, to the base of the doors, around the windowpanes, and around the rear cat flap.

In addition, any glazing fitted externally within doors below 1500mm above ground level should be fitted with safety glass. All safety glazing should be etched as such. Safety glazing does not appear to be present in either door which is considered hazardous.

Furthermore, single glazed units have poor sound and thermal insulation qualities compared with modern equivalents and the thermal efficiency of the property would benefit from their replacement.

Condition Rating: **3**

Given the overall condition of these units, together with the thermal and safety concerns, it would be prudent for these to be replaced in the short-term, in line with the windows. You should seek quotations for this prior to commitment to purchase. Please refer to the advice in section D5 regarding possible restrictions on materials.

We recommend you change all locks upon occupation to enhance security.

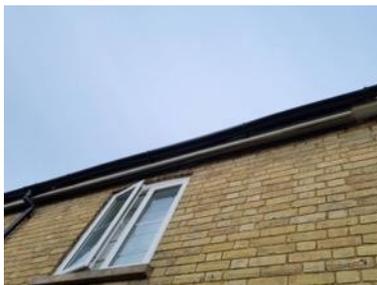
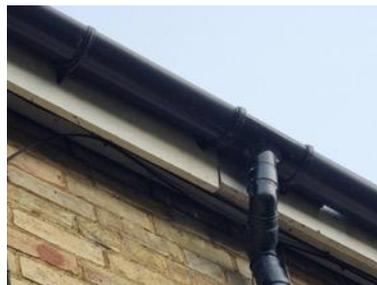
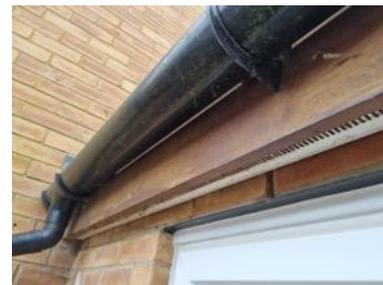
The roof edges are provided with timber fascia and soffit boards which are in a serviceable condition.

The fascia boards to the front have worked slightly loose from their fixings and have slightly twisted. Deterioration will be ongoing, and these should be resecured when the gutters are repaired and modified as advised in section D3 of this report.

The external decorations are deteriorated and new decoration in reasonable course is required. Much of this work will be undertaken at height and it is therefore recommended that you obtain quotations for this prior to purchase. It would be economical to undertake redecoration at the same time as the rear gable timber cladding.

Condition Rating: 2

Please note, a closer inspection of the timber may reveal some concealed deterioration and you should expect that localised repairs may be necessary prior to redecoration.

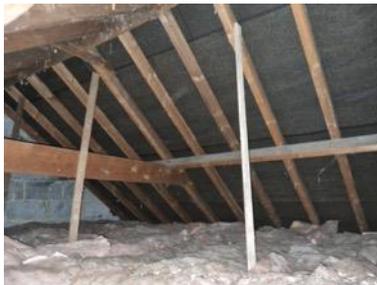
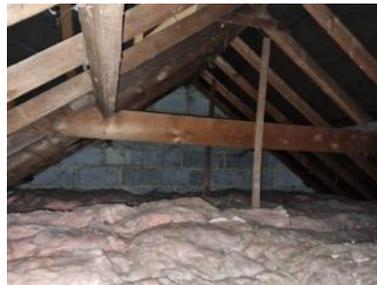
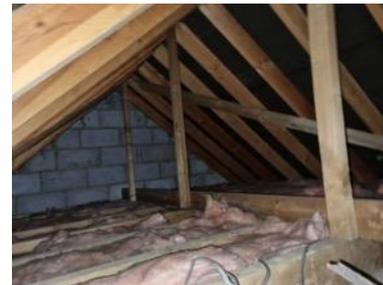
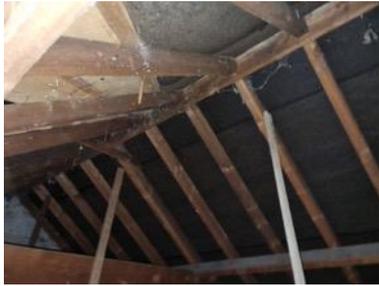
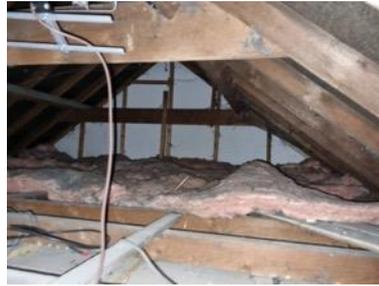
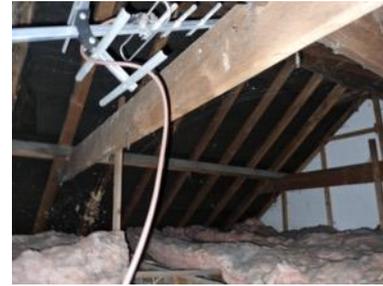
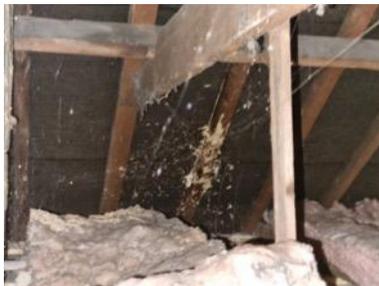
Historic damp staining was noted to the roof rafters. However, no damp was recorded when using an electronic moisture meter and this is within acceptable limits for a property of this age and type.

Given that this is a period property, there is evidence of wood-boring insect activity elsewhere in the property as will be reported, and the ventilation to the roof void is inadequate, there is a risk that the roof timbers may have been affected by wood-boring insect infestation where not accessible.

It is apparent that large wasps' nests have been removed from within the eaves to the front slope of the original roof frame. You should be mindful of further nests that may be present in hot summer months.

Where residue of the nests remains, these timbers will be at risk of sweating which can lead to decay. It is recommended these timbers are inspected up-close as part of the advisory PCA inspection above.

As a precaution, it is recommended that you arrange for a more invasive specialist inspection prior to purchase through a member of the Property Care Association (PCA), with further advice obtained on precautionary treatment measures. Without undertaking such investigations, you must accept the risk of unseen defects, which could be both costly and disruptive to remedy should any significant historic, or active infestation be present.

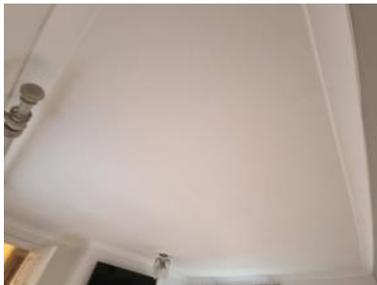
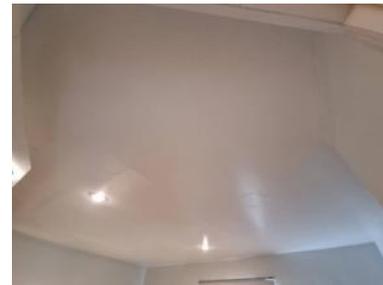
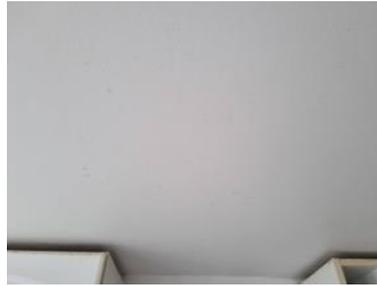
Peeling decorations and minor mould growth were also observed within the bathroom and this is attributed to excessive condensation due to a lack of ventilation, please see section E8 of this report. The loose and peeling decorations should be stripped, prior to the re-application of an appropriate water-proof paint.

There are recessed spotlights installed within the ceilings to bedrooms two and three. These should be checked by an electrician to ensure they are shrouded and provide half-hour fire resistance. You should instruct a reputable electrician to inspect as part of an electrical safety test, please see also section F1 of this report. Any required improvements should be provided with a quotation to undertake repairs, replacement and redecoration as recommended.

Condition Rating: 2

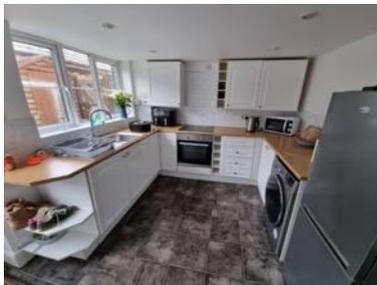
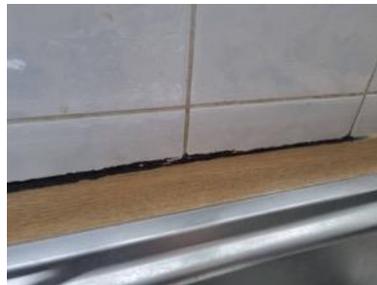
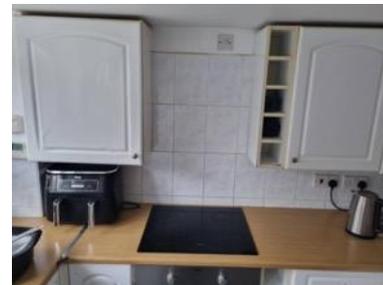
There is an electric hob fitted and you should confirm with your legal adviser whether this has any electrical safety certification. Please refer to section F1 of this report.

Most of the distribution and waste pipework is concealed behind the units and leaking pipework or other defects may not be readily apparent.

Condition Rating: 2

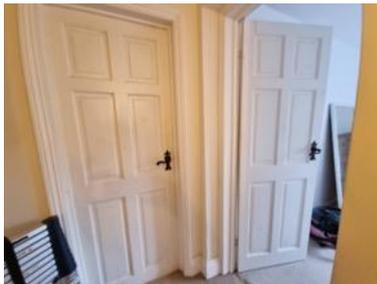
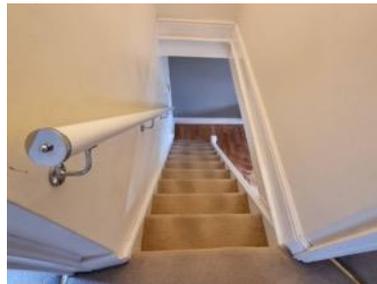
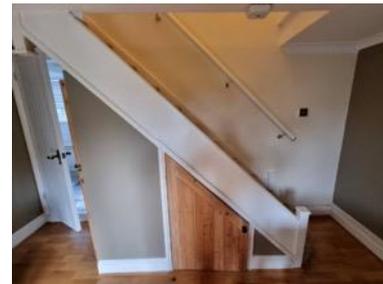
There is no balustrade (banister) to the staircase. This is not compliant with regulations and is a health & safety issue, due to the possibility of falling. The provision of a banister should be provided as a matter of urgency, and you should seek quotations for these works prior to commitment to purchase.

Condition Rating: 3

You should consider installing a ventilation grille to the storage areas beneath the staircase in order to reduce the risk of condensation.

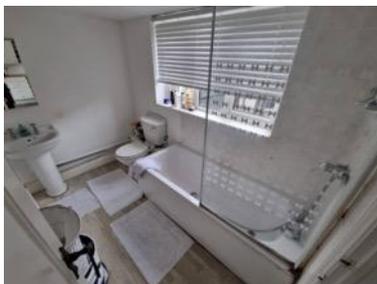
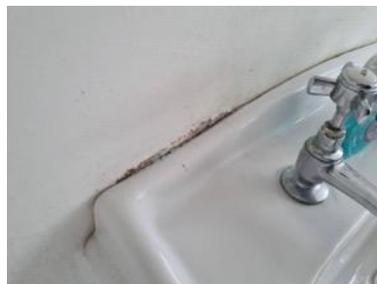
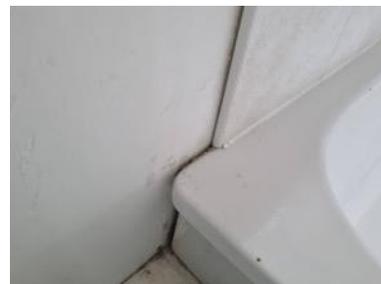
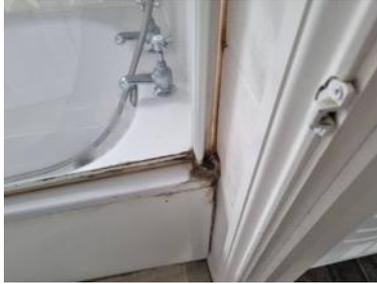
Sanitary fittings are dated and worn although apparently serviceable. As part of the general upgrading of the premises you may wish to consider replacing them.

The flexible sealant around the sanitary ware is significantly deteriorated, most notably to the bath and basin, and there is a risk that water penetration has, or will, occur. The sealant should be replaced as soon as it is possible to do.

Condition Rating: **3**

A precautionary inspection of the enclosed area beneath the sanitary fittings is also recommended before purchase, in order to rule out whether water damage has occurred as a result of this deterioration, which may not be readily visible. Without exposure, the risk of unseen defects will exist.

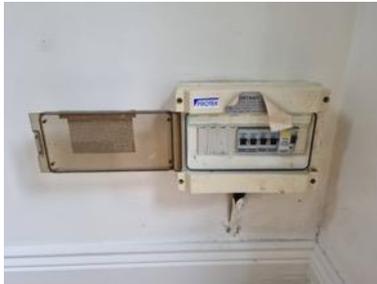
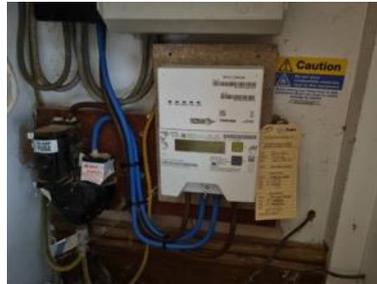
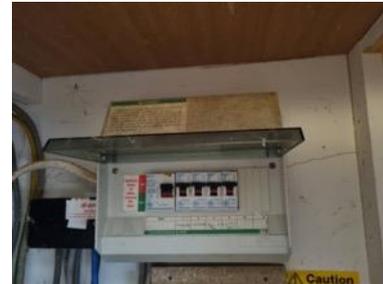
We have concerns regarding the age of the installation which we believe will not meet current safety standards. Due to our concerns, together with no signs of a recent test of the electrical installation, we recommend an electrical inspection is completed prior to legal commitment to purchase with all recommendations fully costed and implemented.

Condition Rating: **3**

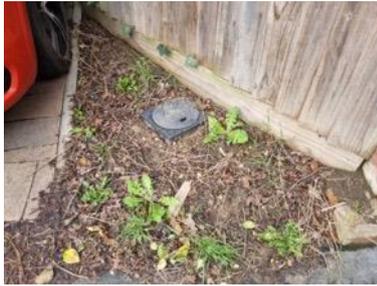
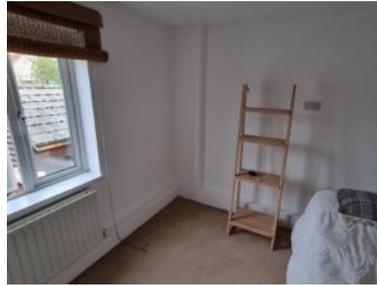
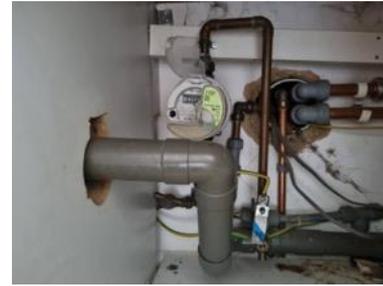
We believe that bedroom three, within the rear extension, may have initially been used as a bathroom, evidenced by the close proximity of the soil and vent pipe externally, and boxing in around the walls within this room. There is a risk that redundant pipework remains, which if not properly disconnected could cause leakages.

Condition Rating: **2**

Prior to purchase, it is recommended that a reputable plumbing contractor exposes these areas and quotes to fully remove any redundant pipework, as part of the overall improvement to the property.

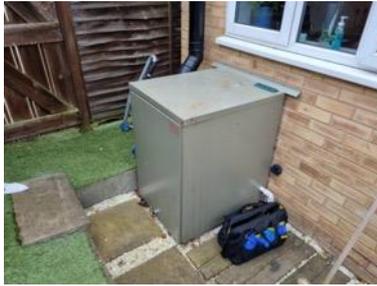
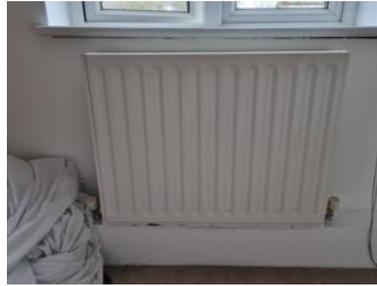
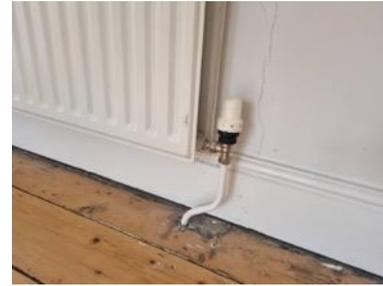
We believe that the replacement boiler was installed approximately 4-5 years ago. You should request a copy of the Building Regulations Compliance certificate for the installation prior to purchase. In the absence of any such paperwork, the installation may not comply with Building Regulations, and this would need to be investigated further by an appropriately registered heating engineer. There may be guarantees for the installation that can be transferred upon sale.

Heat is provided to a number of pressed steel radiators via 15mm pipework. The radiators and visible pipework appear in satisfactory condition, with no significant corrosion or leakages noted.

Condition Rating: 3

Thermostatic radiator valves (TRVs) should ideally be fitted to all radiators where absent. These can be fitted retrospectively to help improve energy efficiency as they allow for individual heat control over each unit.

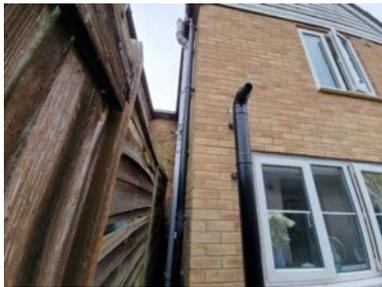
The soil and vent pipe is of uPVC construction and is in serviceable condition at present. As mentioned in section F3, it is possible that this waste pipework is now redundant, and this matter should be investigated by a reputable plumbing contractor.

There is a macerator toilet present within the garden studio. These are noisy and can be problematic, with a requirement for high levels of maintenance. They should be used with care in order to ensure undue blockages are not encouraged. A macerator is only appropriate where an alternative traditionally plumbed toilet is also available for use within the property, this is because macerators will not operate in the event of a power failure. Please refer to section G2 of this report.

Condition Rating: **2**

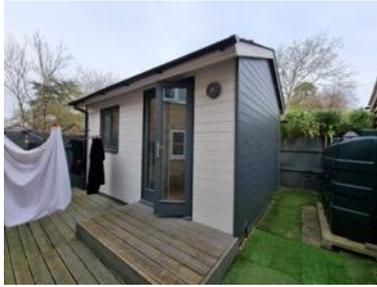
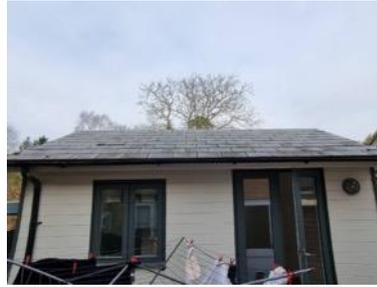
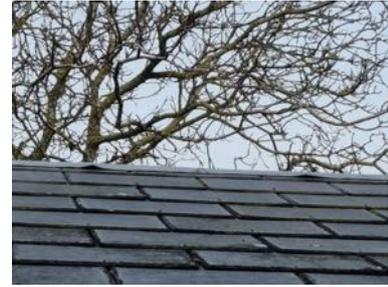
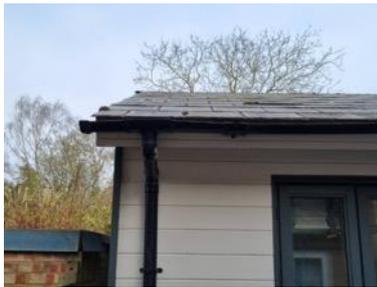
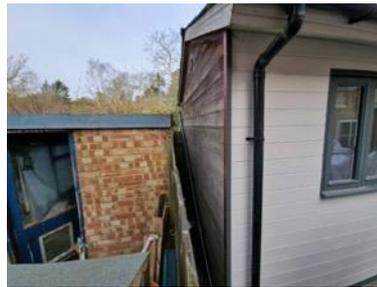
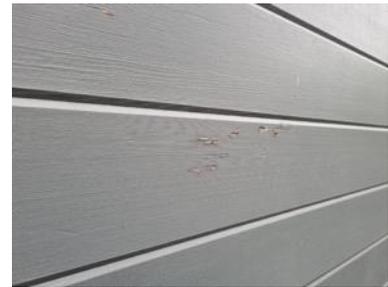
Condition Rating: **3**

The electrical services to the outbuilding, to include the hot water and shower units, should be tested by a qualified electrician alongside the electrics to the property. Please see also section F1 of this report.
