RICS HOME SURVEY LEVEL 2

- SURVEY & VALUATION

Example Report

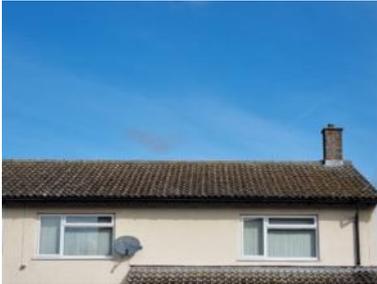
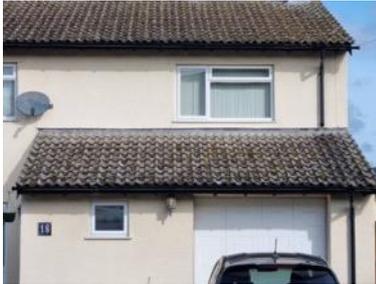
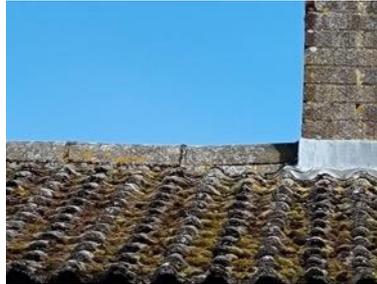
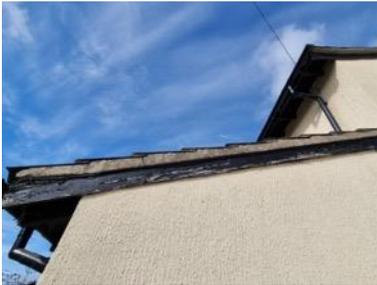
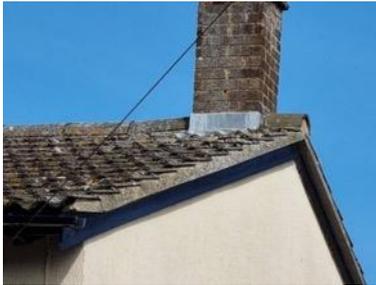
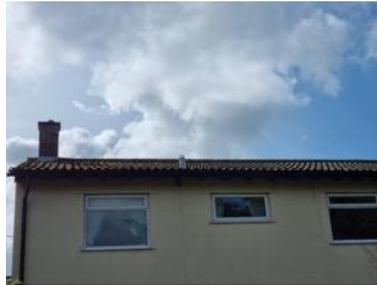
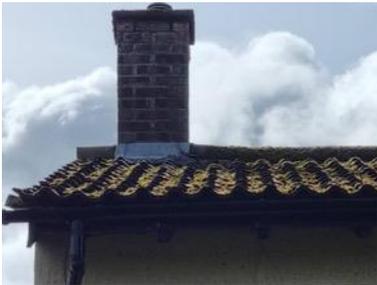
Please note the roof verge under cloak may include asbestos containing materials, depending on their age. Care should be taken with future maintenance. See 'Local environment' of this report.

There is no apparent method of ventilation of the roof void. Please see section E1 of this report for further advice.

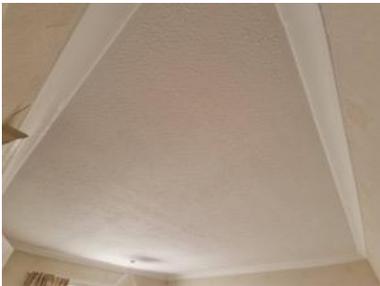
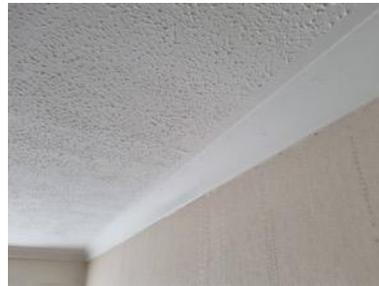
Where decorative plaster coving is fitted within the property, this appeared to be complete with no signs of any significant defect noted. Please note that coving can conceal a degree of settlement cracking.

We are pleased to report the ceilings appear to be generally complete with no signs of significant cracking, undulation or distortion noted.

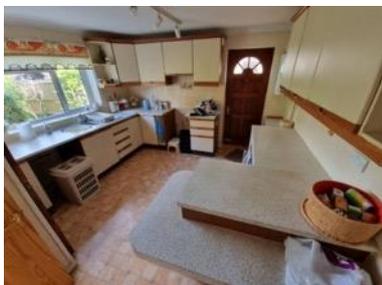
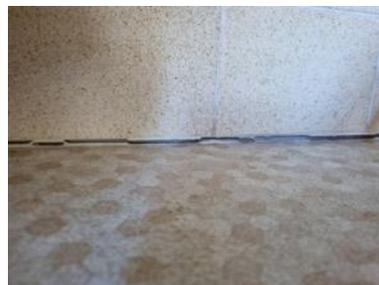
Most of the distribution and waste pipework is concealed behind the units and leaking pipework or other defects may not be readily apparent.

It would be prudent to ensure that mechanical extract ventilation to the exterior is maintained with the replacement kitchen to reduce the possibility of condensation problems occurring.

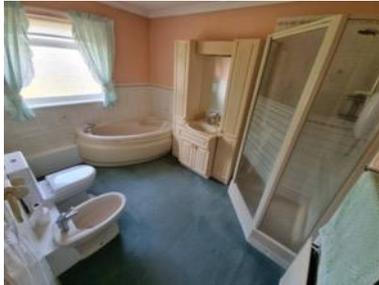
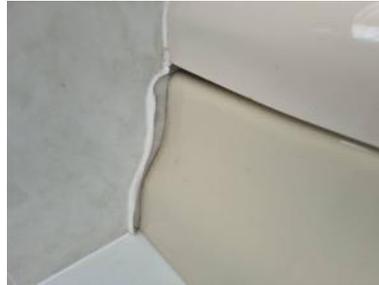
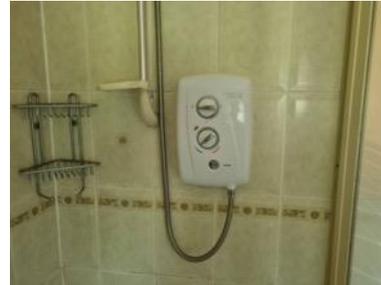
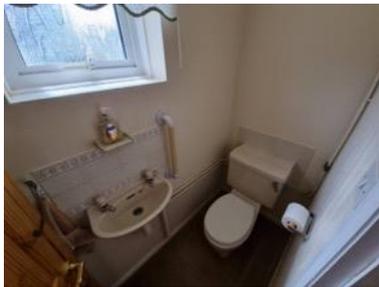
The water pressure was checked to several draw-off points and found to be adequate. Water pressure can vary seasonally and during times of high demand, both within the property and in the locality. It is recommended that should you wish to install water pressure sensitive items, such as a power shower, that further enquiries are made initially.

Most of the distribution and waste pipework is concealed beneath or behind sanitary ware items and whilst there were no obvious signs of leaks, the risk of hidden defects exists.

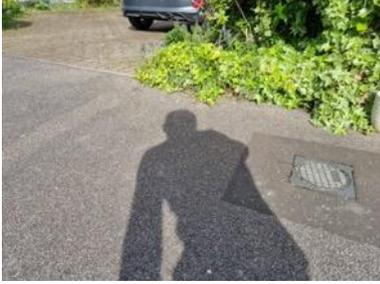
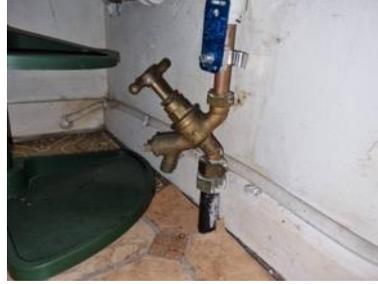
The internal rising main and stop tap are located within the kitchen pantry.

The external stop tap is located in the front footpath. You should confirm whether a water meter is provided.

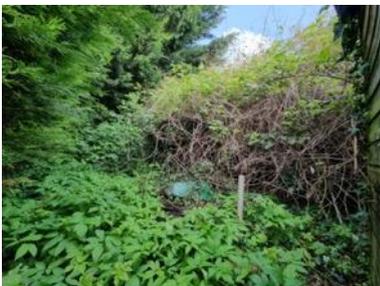
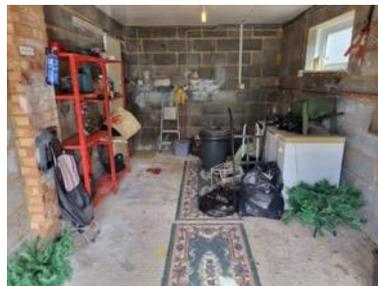
G1 Garage

No significant structural defects were apparent to the garage at the time of inspection.

There is an up and over door that was operated and appears to be in a serviceable condition.

Please note, the garage ceiling materials appear to be of a material that may contain asbestos fibres, depending on their age. Areas of damage were noted to the ceiling materials and there is a risk that this could release harmful asbestos fibres. It is advised that these materials are tested by an asbestos contractor prior to purchase, with all recommendations to remove and replace the ceiling finish fully costed.

Water staining was noted to the ends of the first-floor structure to the front of the garage. These areas were tested and found to be dry at the time of the inspection and are attributed to staining that likely occurred at the initial time of construction.

The floor level between the living accommodation and the garage is not in accordance with Part B – Fire Safety of the current Building Regulations. A height of 100mm is required between the garage floor and the base of the door reveal, in order to prevent hazardous spillages from entering and contaminating the property. Current Building Regulations are not enforced retrospectively however if you intend to store hazardous or contaminate liquids within the garage then where practical and possible it is recommended that the required height is provided, and you should budget accordingly.

Where there is accommodation to the first-floor over the garage, you should ensure that any future replacement of the ceiling materials is carried out in a sealed fire-retardant material, in line with current Building Regulations.

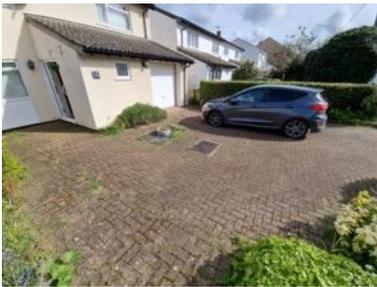
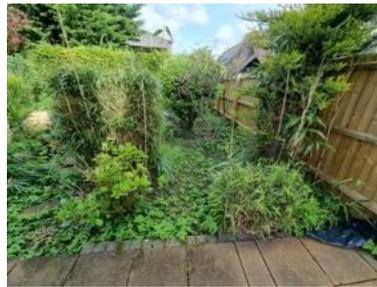
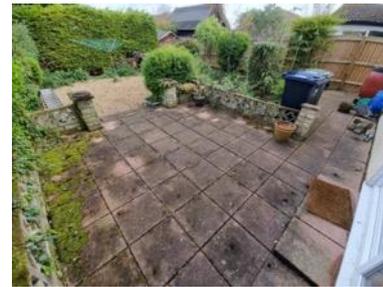
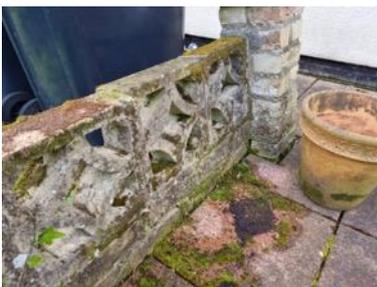
The property is approached via a made driveway, which is in reasonable condition at present, however we have noted our concerns regarding surface water discharge.

Bamboo is present located within the rear garden. It can threaten foundations and push through drains and brickwork as well as exploit weaknesses and cracks in concrete. The plants cannot be killed-off with herbicides and will need extensive work to destroy the roots. This is a very invasive plant, and we recommend it is removed, particularly where it is in close proximity to the drainage installation. You should seek further specialist advice in this regard prior to purchase. Alternatively, if you do not wish to remove the bamboo, a regular maintenance schedule will need to be put in place by a specialist.

You should upgrade paths and patios, which are in need of improvement and may be slippery in wet or icy conditions.

Where there are garden walls, these features will require high levels of maintenance and are currently suffering from deterioration, evidenced by cracking and leaning. You should seek quotations for repairs prior to commitment to purchase in order to budget accordingly, as these works may be costly.

Boundaries are provided with a combination of timber fencing and hedging. Much of the boundaries were concealed and you should anticipate that ongoing maintenance and repair will be required.

It is recommended that a certified copy of the Deed Plans be obtained, and boundaries checked on site, with any discrepancies investigated further, to assist in reducing the possibility of boundary disputes with adjoining owners.
